• AFTER IMPACT DAMAGE •

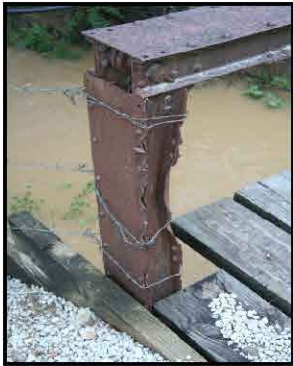
PROBLEM	SUGGESTIONS		EXAMPLE IMAGES
	DO:	DO NOT:	
Dented or bent truss members.	<ul style="list-style-type: none"> • Notify TxDOT Area Engineer, TxDOT District Bridge Engineer, or structural engineer consultant. 	<ul style="list-style-type: none"> • Heat-straighten members because it can result in subsequent fracturing of members, particularly when members were previously heat-straightened. • Weld steel members to the truss members in an attempt to fix damage or strengthen members, which can add undue stress to other members and worsen damage.

<p>DENTED TRUSS MEMBER</p>
Cracked truss members.	<ul style="list-style-type: none"> • Notify TxDOT Area Engineer, TxDOT District Bridge Engineer, or structural engineer consultant. 	<ul style="list-style-type: none"> • Weld steel members to the truss members in an attempt to strengthen members, as this can add undue stress to other members and worsen damage.

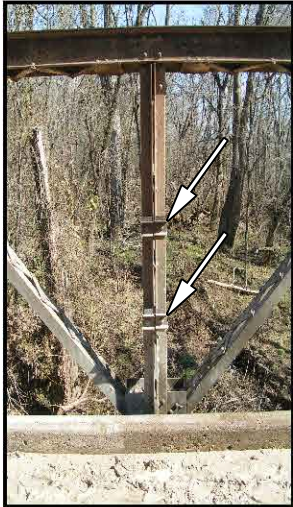
Missing or severely damaged steel railing.	<ul style="list-style-type: none"> • Notify TxDOT Area Engineer, TxDOT District Bridge Engineer, or structural engineer consultant when replacement cannot be conducted with compatible members. • Replace steel members with compatible members (when possible), and connect to the truss using the same bolt holes as previous railing. 	<ul style="list-style-type: none"> • Weld new steel members to the truss, as this can add undue stress to other members and worsen damage. • Drill new bolt holes or enlarge existing holes, as this can compromise the structural integrity of the bridge and worsen damage.

<p>MISSING STEEL RAILING, ONLY THE BRACKETS REMAIN</p>

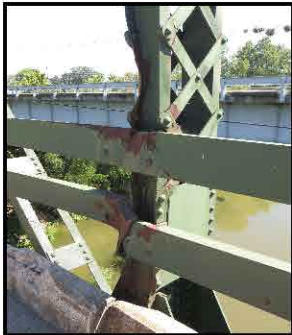
PROBLEM	SUGGESTIONS		EXAMPLE IMAGES
	DO:	DO NOT:	
Scraped or damaged paint.	<ul style="list-style-type: none"> • Create an adhesive surface by lightly scoring and sanding the area by hand; spot treat paint corroded area. 	<ul style="list-style-type: none"> • Delay repairs as this can lead to corrosion at areas of impact.

<p data-bbox="1053 900 1273 946">SCRAPED PAINT ON VERTICAL AND RAILING</p>
